Ministry of Environment, Science, Technology and Innovation (MESTI)	Mission Report Summary (*)																		
Submitted by : Cynthia Asare Bediako, Peter Dery and Israel Fiagbe	Date 15 th March 2020																		
Mission: Monitoring visit on the Rehabilitation of Nabugaan, Tarso Kulfou, Welembelle, Bong-Dua and Kpelewega Dams.	AF Project Management Unit																		
Mission Dates: 3-12 February 2021																			
<p><u>Background</u></p> <p>The Government of Ghana (GoG), through the Adaptation Fund financed Program titled “Increased resilience to climate change in northern Ghana through the management of water resources and diversification of livelihoods” aims at addressing climate change-induced decreases in the availability and increasing unpredictability of water resources, and the associated negative impacts of these trends on the livelihoods of rural communities. The main objective of the program is to enhance the resilience and adaptive capacity of rural livelihoods to climate impacts and risks on water resources in Northern Ghana.</p> <p>Following the procurement of Contractors by the MESTI, based on the feasibility study reports with details of the status o

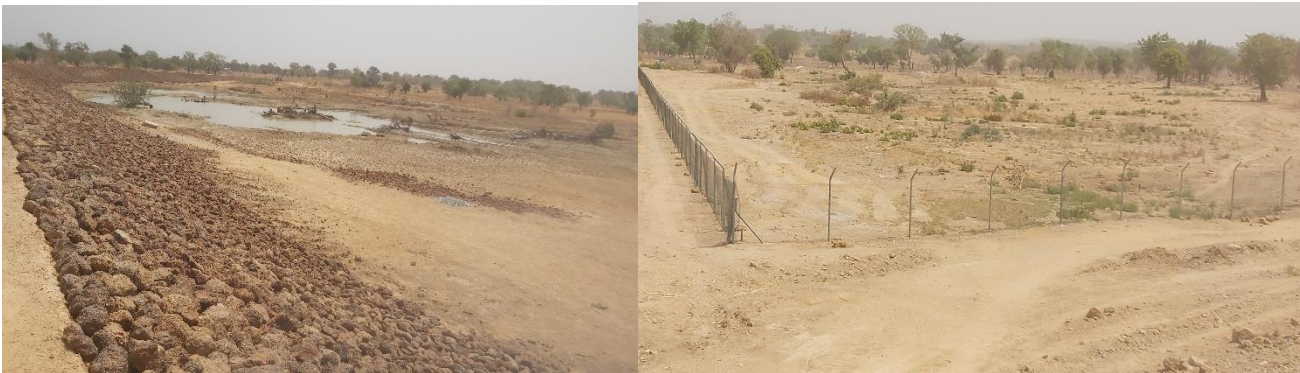
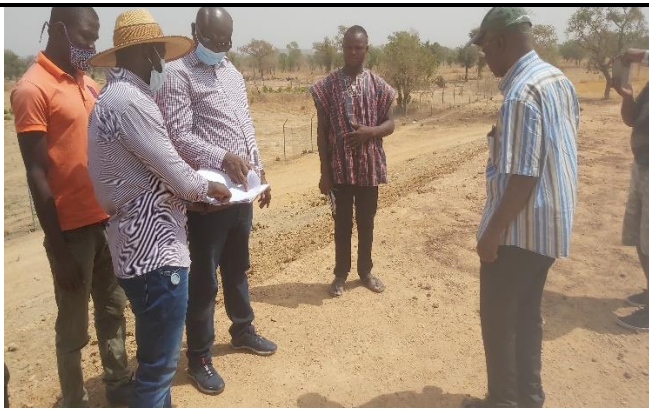
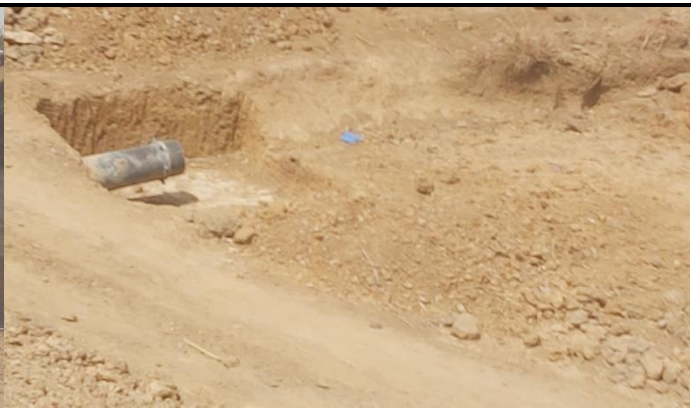
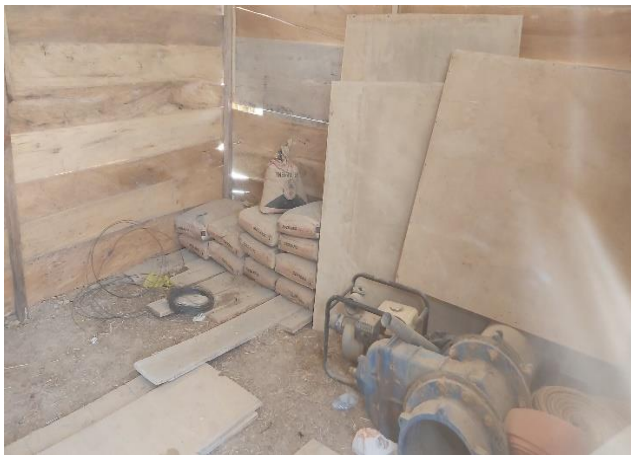
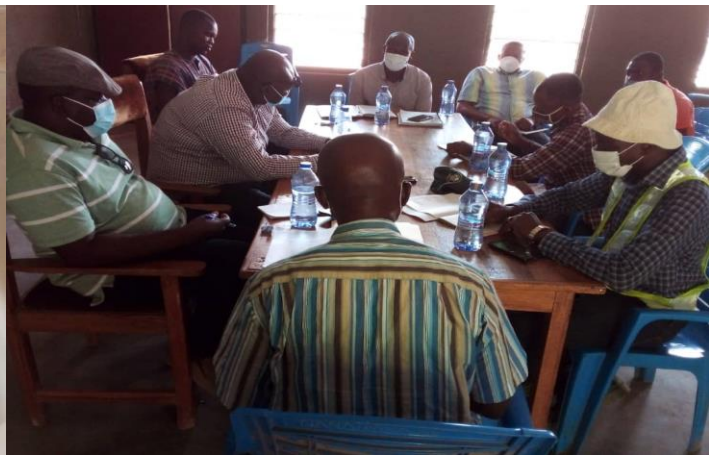
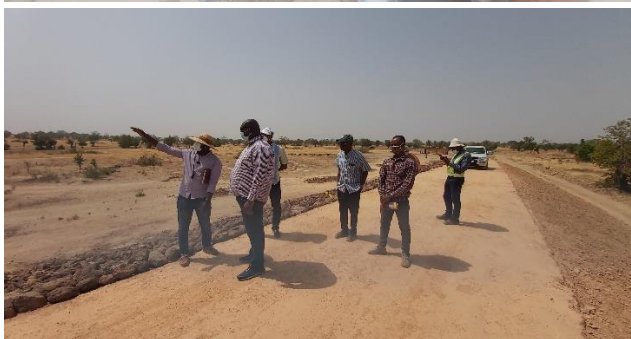
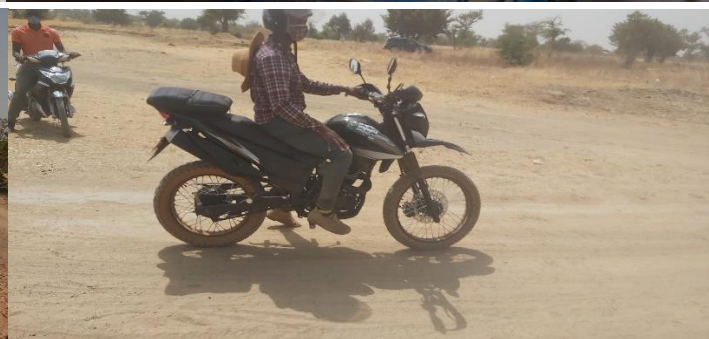
Pictures:

- The embankments had been completed
- Fencing of the irrigable area had been completed
- Laying of protective boulder had been completed
- Conduit pipes laid and connected from dam to irrigable land/vegetable farms

- Spillway under construction
- Remaining tree trunks to be removed
- Inlet and Outlet valves to be fixed
- Grassing along the embankments
- Backfilling to constructed channels/laterals

- The activities of cattle (crossing over to the embankment into the dam for water) is a big threat to the dam. According to the site engineer, their weight and foot tracks along the embankment could weaken it over time and could damage the dam.
- The Project Coordinator entreated the Assembly man, who was present, to educate the owners and caretakers of the cattle of the implication of their activities along the dam embankment on the sustainability of the dam for the use by both human and Livestock.

- The Contractor to remove remaining tree stumps from the reservoir
- Inlet and Outlet valve should be fixed
- Laterals must be constructed for the distribution of water to the irrigable area
- The construction of the spillway must be completed before the rains set in
- Contractor to comply with Consultant's directives to avoid unnecessary delays in approvals.
- Regular MEST/UNDP visit to sites could help speed up work.

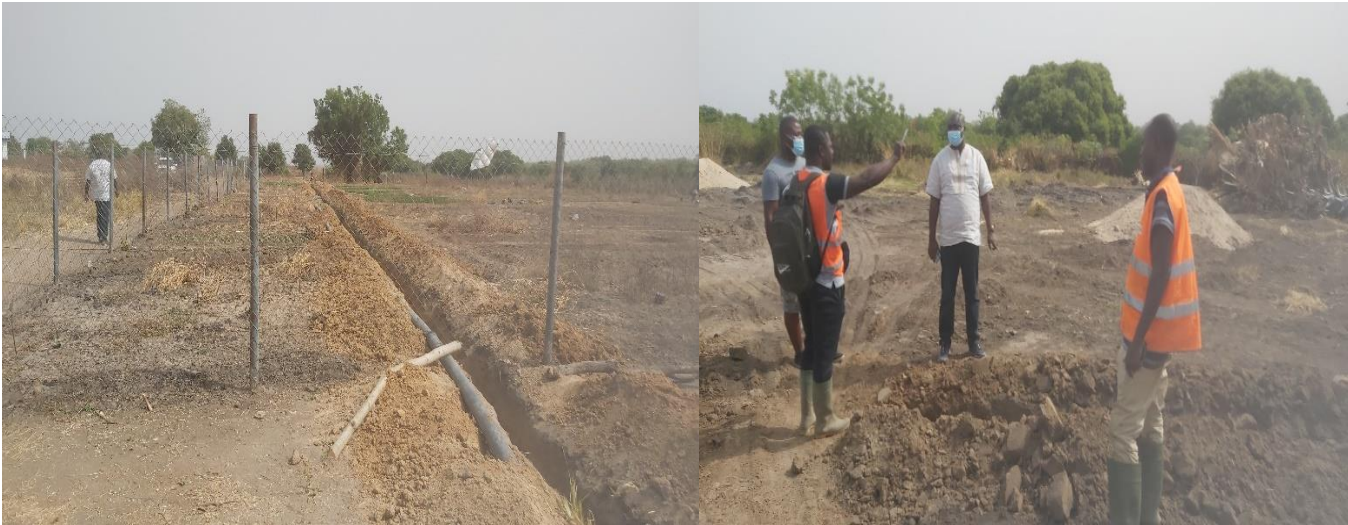
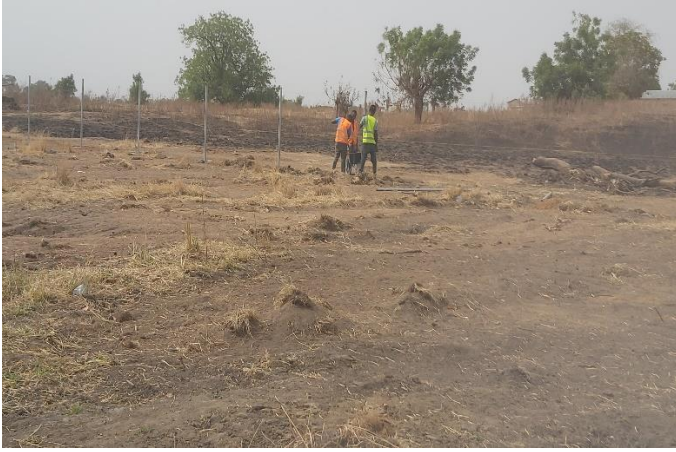
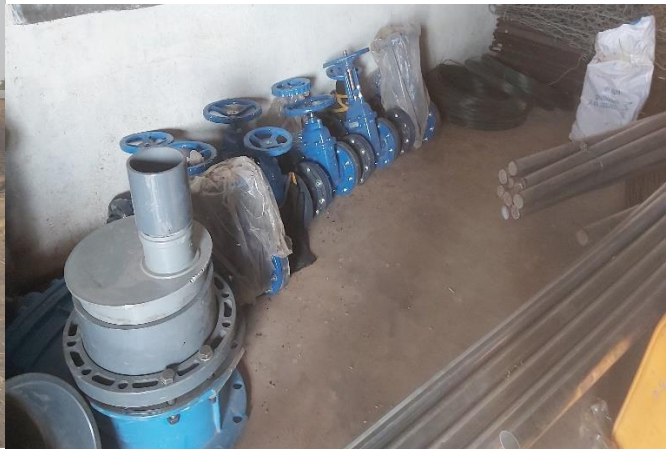
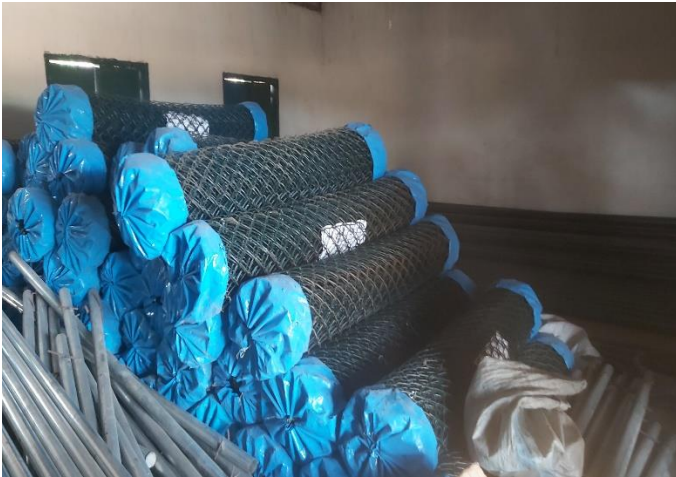
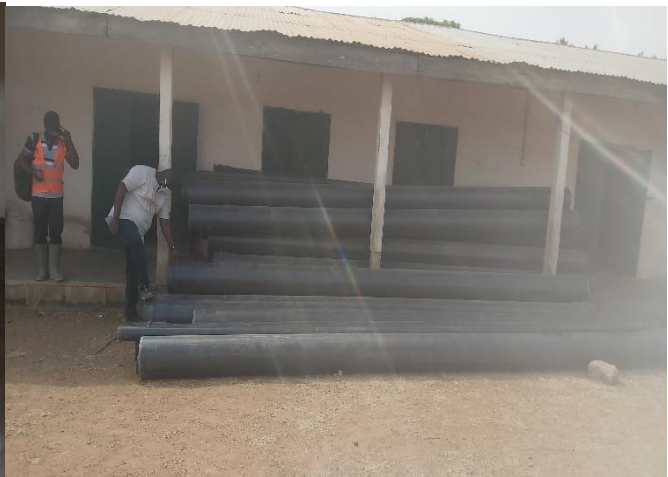
Picture:

At the time of our visit, not much work has been done by the Contractor. The reason given was that it was due to the late start of the works as a result of the revocation of the initial contract and change of site from Savelugu in to Welembelle. The following were the key achievements:

- Erection of chain link fence around the 3-hector irrigable land had commenced.
- Laying of PVC pipes from the area marked for the outlet chamber to the irrigable land was far advanced.
- Almost all the materials required for the assignment had been procured and stored.

- Actual construction of the embarkment
- Actual construction of the Spillway
- Laying of protective boulders
- Construction of the In-let and Out-let chambers
- Laying of in-let and out-let pipes and laterals
- Fixing of conduit inlet and out-let valves
- Gravelling, laying of black soil etc.

- The Contractor must be pushed by the PMU to commence works immediately, as enough funds (advance mobilization) has been paid to him.
- The Contractor must hire a private security for the warehouse where the materials and other equipment for the works are stored. The closeness of the warehouse to the Police Station does not necessarily constitute adequate security.
- Contractor to comply with Consultant's directives to avoid unnecessary delays in approvals.
- Regular MEST/UNDP visit to sites could help speed up work.

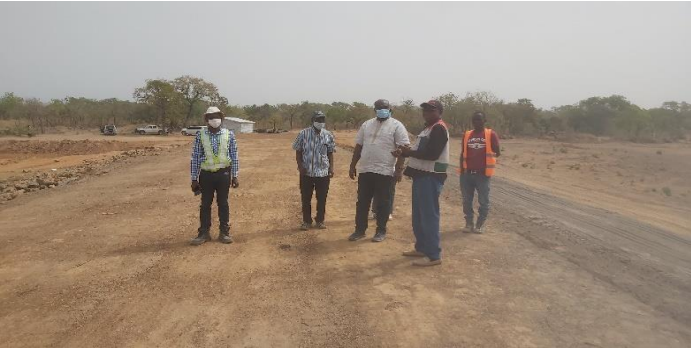
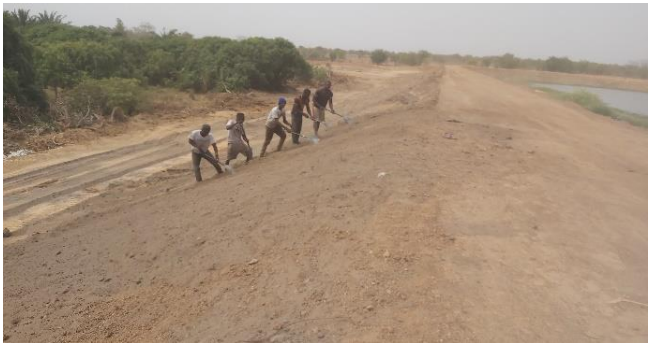
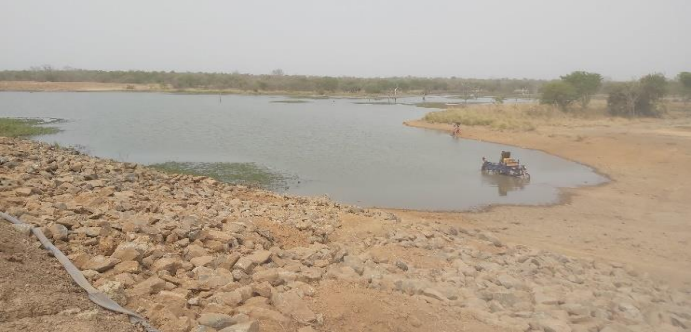
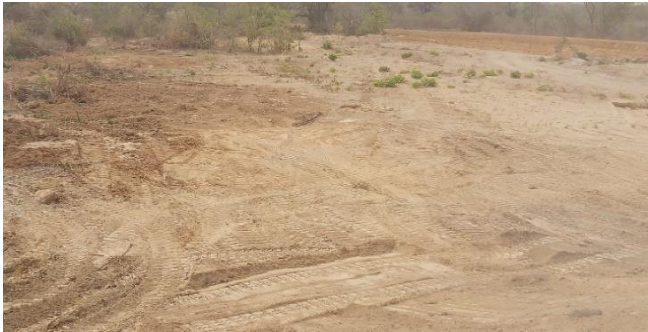
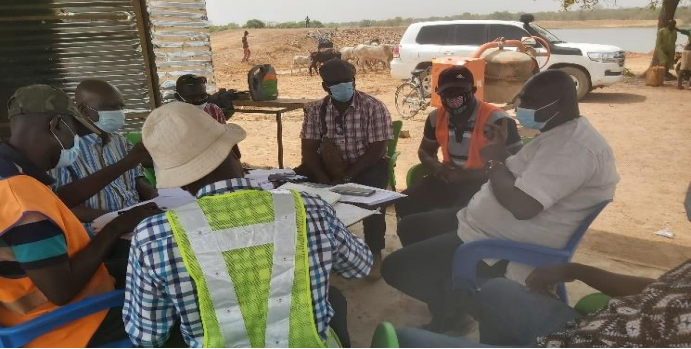
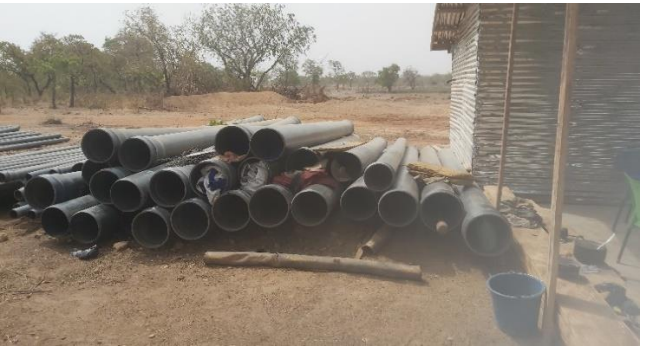
Pictures:

- Dam body enlarged to designed angle, length, width and height
- Water reservoir flow control established
- Dam body Tree, bushes, roots and stamps cleared
- Planting of vertiva grass along embarkment ongoing
- Construction of Spillway in progress
- 3-hector land earmarked for irrigation farming cleared

- Erection of chain-link fence around 3-hector irrigable land
- Smoothing of the walkway by topping up soil to get the required level per the Consultant's estimates
- Laying of boulders
- Laying of pipes from the outlet chamber to the irrigable farm
- Dressing of dyke
- Construction of spillway beam

- The contractor had destroyed a vegetable farm established by one of the NGOs engaged the project under the Alternative livelihood project. The portion of land was within the 3-hector land allocated by the community. It was evident the contractor did not consult the NGOs or the beneficiaries. The Project Coordinator requested a meeting between the Contractor, the NGO, the beneficiaries and community leaders for an amicable solution to the problem

- The Contractor has to complete the filling up of the walkway with additional sand to level up
- Issues relating to the destruction of an existing vegetable garden within the 3-hector land must be resolved amicably with the NGO (FORG) and the existing beneficiaries as well as the new ones.
- Contractor to comply with Consultant's directives to avoid unnecessary delays in approvals.
- Regular MEST/UNDP visit to sites could help speed up work.

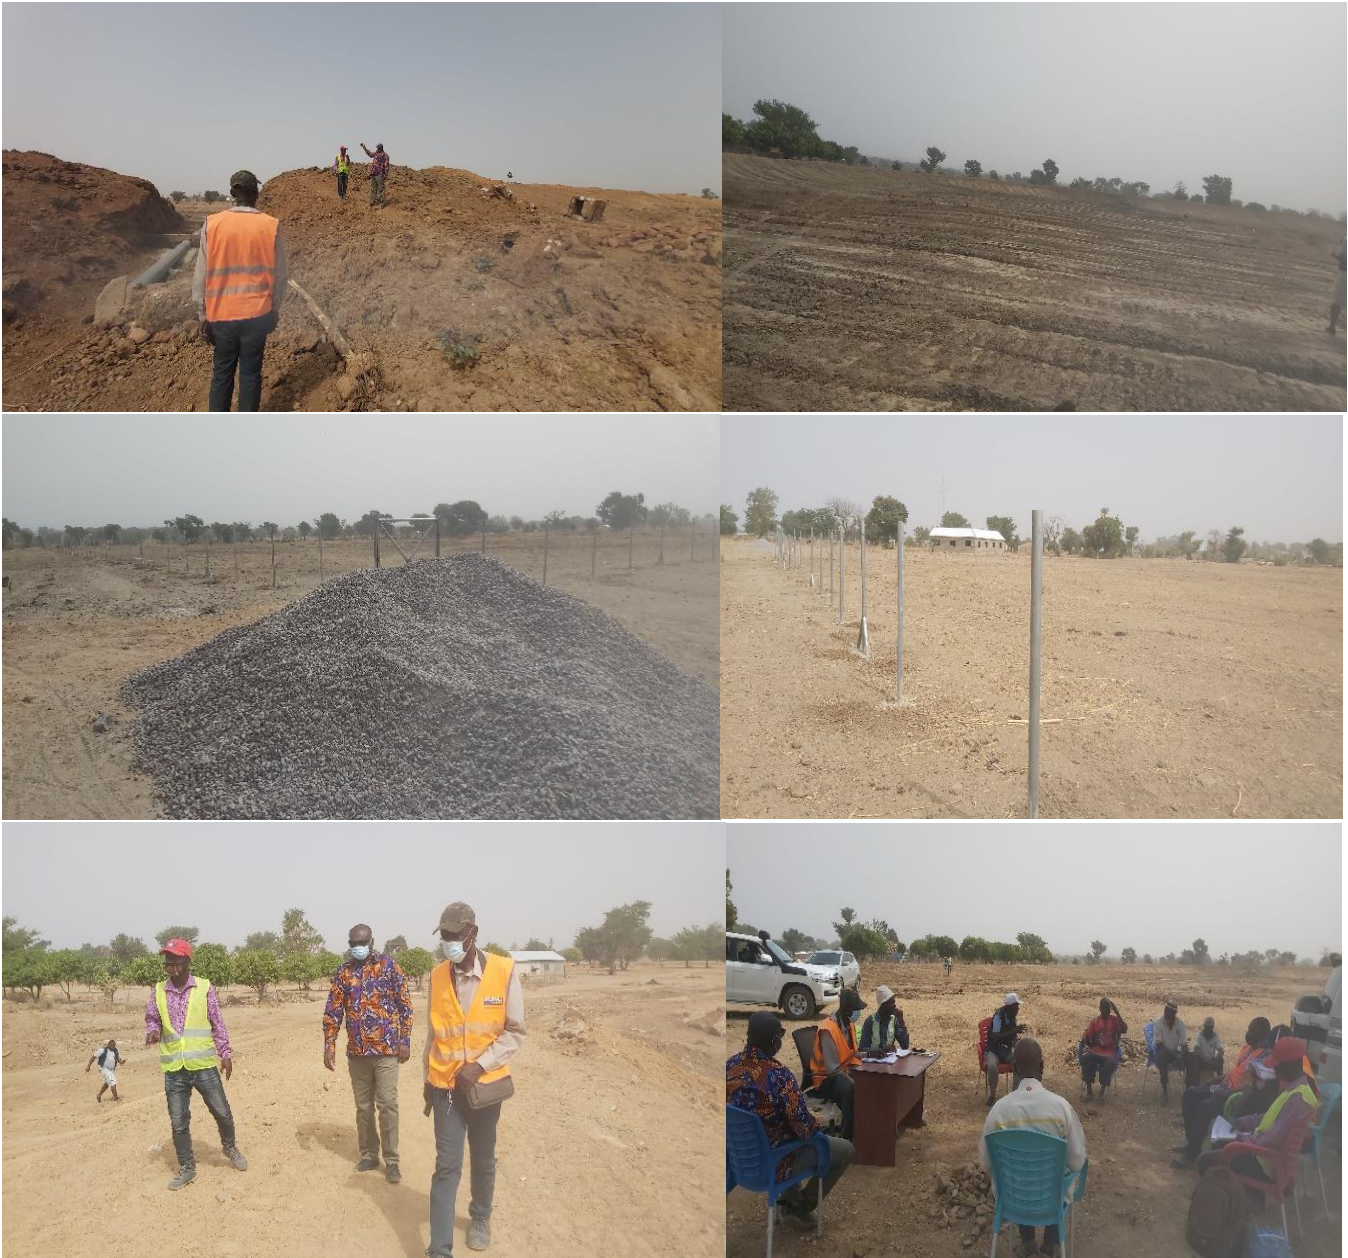
Pictures

- Water reservoir de-watered
- Dam area cleared of trees, tree stumps etc
- Some level of work has been done on the existing embankment and walkway
- Walkway breached to pave way for the construction of base for PVC in-let and out-let pipes
- Old boulders gathered
- Erection of Chain Link fence on-going

- Actual construction of the embankment and walkway
- Actual construction of laterals
- Actual construction of the Spillway and other related works
- Laying of protective boulders
- Construction of the In-let and Out-let chambers
- Fixing of conduit inlet and out-let valves
- Gravelling, laying of black soil etc.
- Completion of the erection of the Chain link fence
- Connecting distribution pipes from the Outlet valve to the irrigable land

- We observed that the main cause of delay in the works was the rental of faulty machinery and equipment, some of which are not fit-for-purpose.
- The Chief and community members visited us at the site complained about the Contractor not engaging them periodically to discuss progress of work, challenges, as well as incorporate their concerns in the overall works, that they believe would benefit them.

- The Contractor, as a matter of urgency needs rent/hire equipment and machinery that are in good working condition and also fit for purpose
- The Contractor needs to provide financial resources regularly to the technical team for prompt acquisition of critical materials for the assignment
- Contractor to comply with Consultant's directives to avoid unnecessary delays in approvals.
- Regular MEST/UNDP visit to sites could help speed up work.

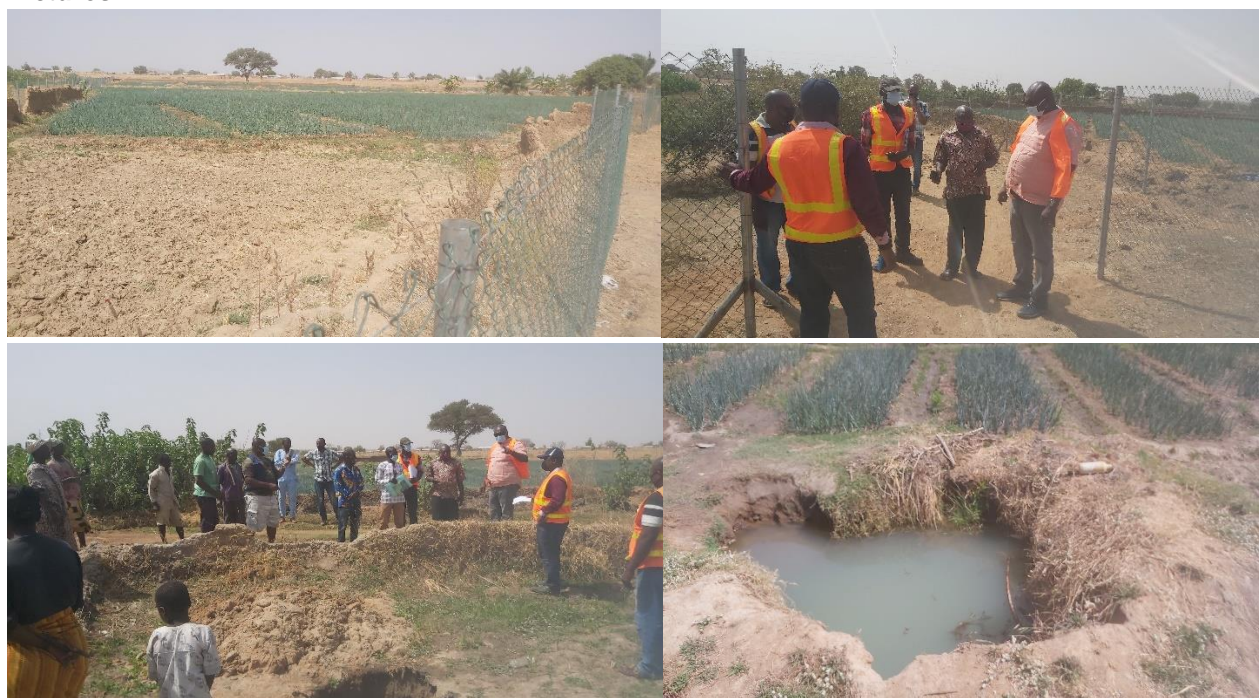
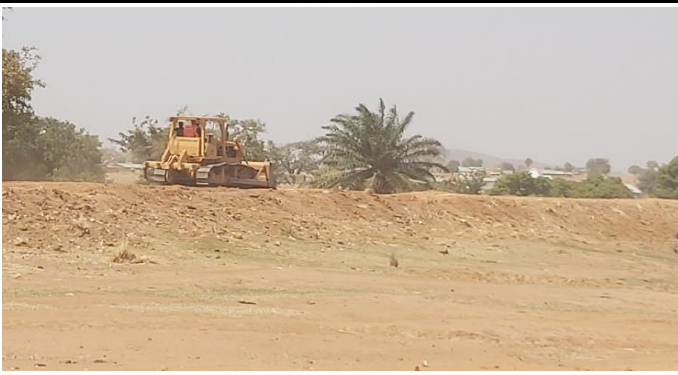
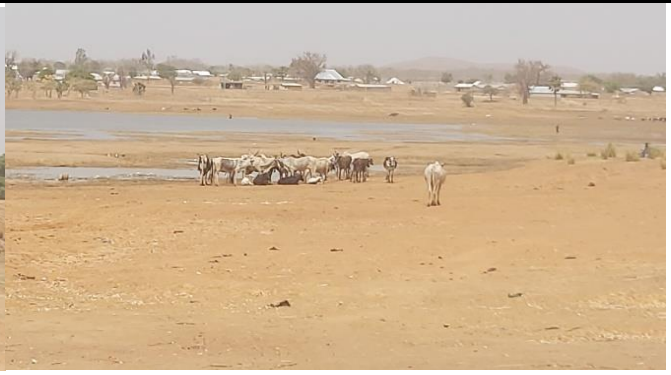
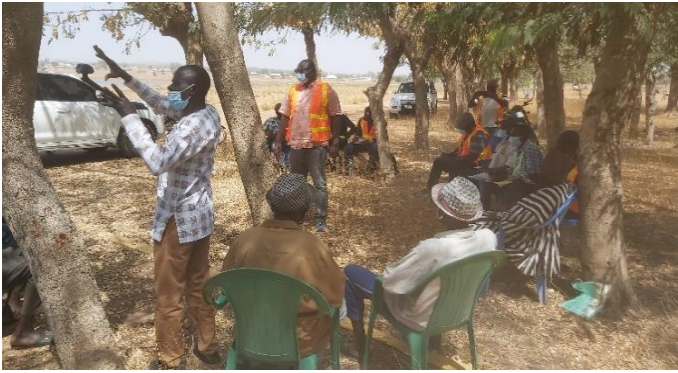
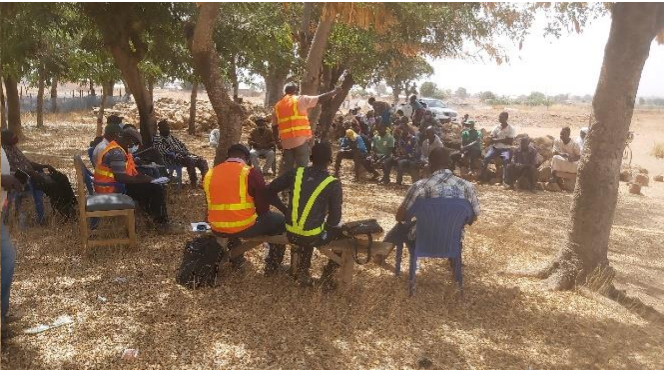
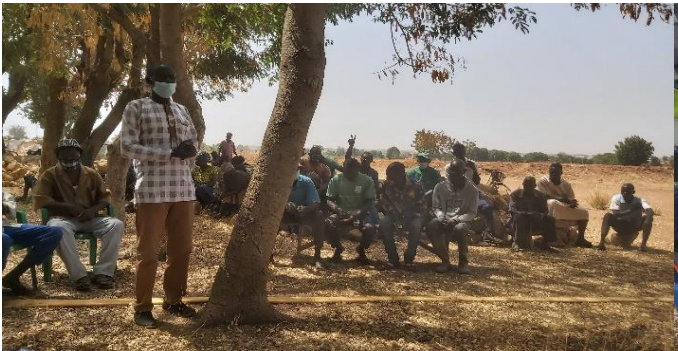
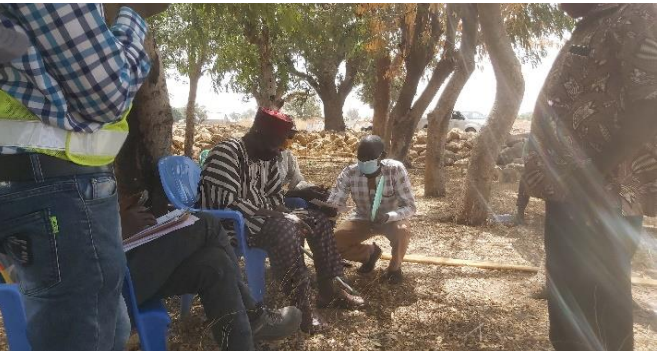
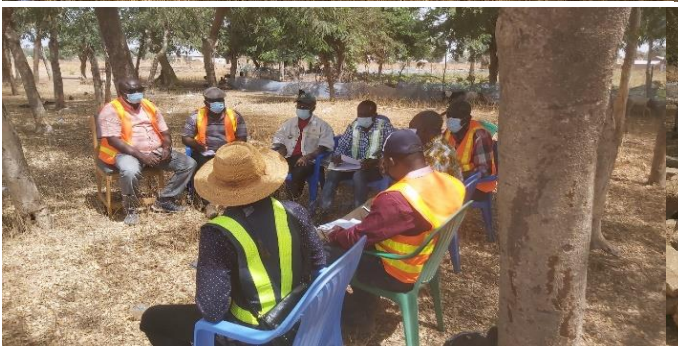
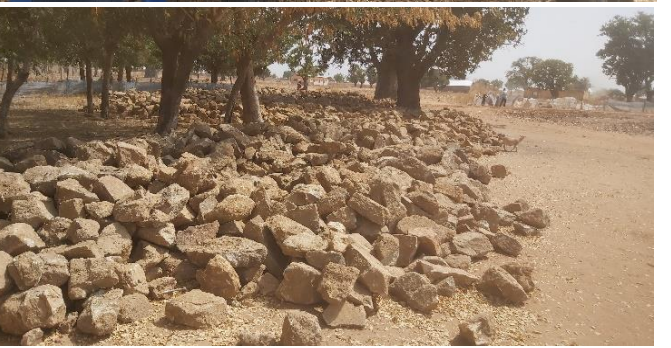
Pictures:

The only completed activity as at the time of our visit was the chain link fence that had been completely erected. Works on the actual rehabilitation had stalled due to the non-cooperative attitude of the Chief, elders and community members. The reservoir had been de-watered but not completely. The reason was to give human and livestock access to some water while part of the rehabilitation works would be going on.

- The Contractor, as a matter of urgency needs rent/hire equipment and machinery that are in good working condition and also fit for purpose
- Now that issues with the Chief and Community have been resolved, the Contractor needs to provide financial resources regularly to the technical team for prompt acquisition of critical materials for the assignment
- Contractor to comply with Consultant's directives to avoid unnecessary delays in approvals.
- Regular MEST/UNDP visit to sites could help speed up work.
