Jandar Power Plant GT4 Overhaul

Chief Engineer: Adnan Halak Report Prepared By: CMC Power Generation Sunday, December 17, 2017

Rehabilitation Maintenance Procedure

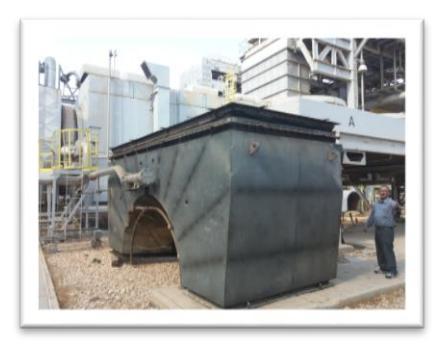
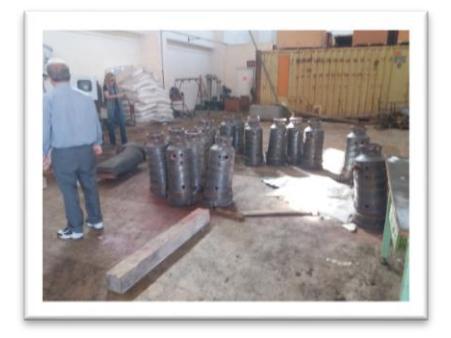
Removed insulation from the turbine, dismantled the air ducts and flame tubes, then released locks, opened manholes and lifted ceiling of the turbine.

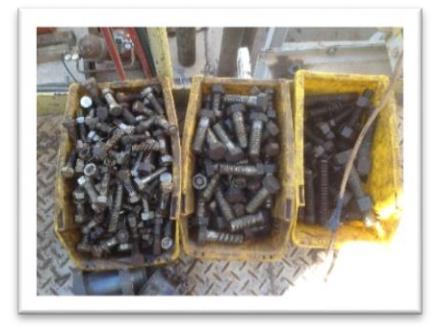
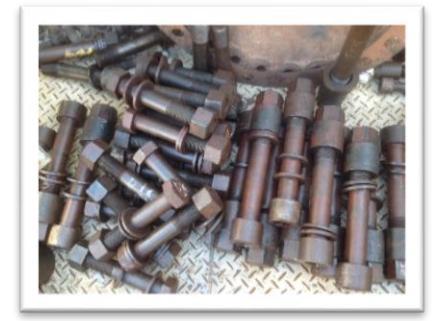
Removed screws and bolts from the turbine casing, airway ducts, and compressor casing.

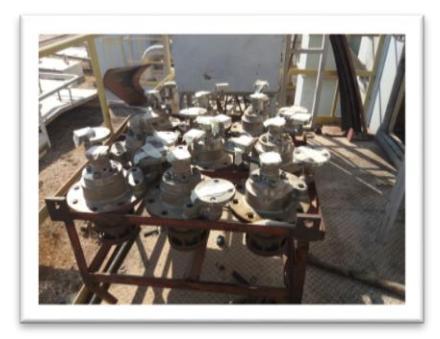
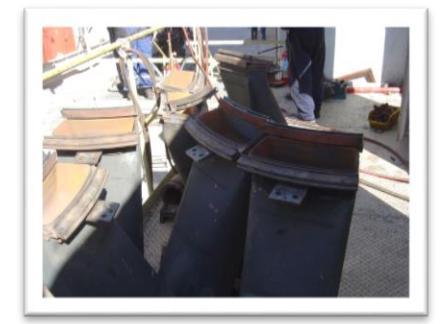
Removed flame detectors, flame igniters and 18 combustor baskets and transition pieces.

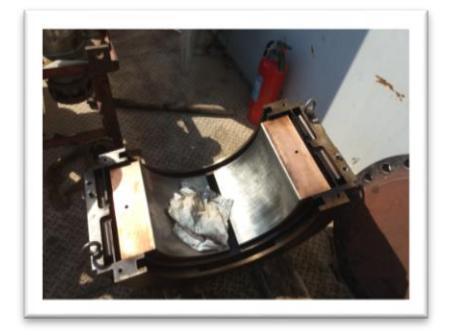
Cleared and dismantled the beds, air ducts and oil circuit pipes.

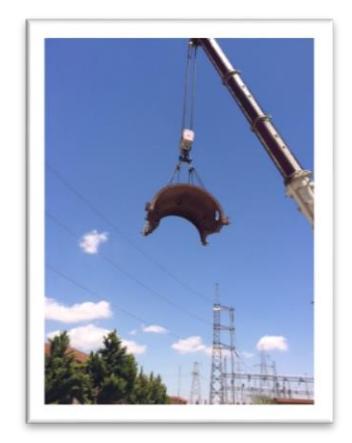
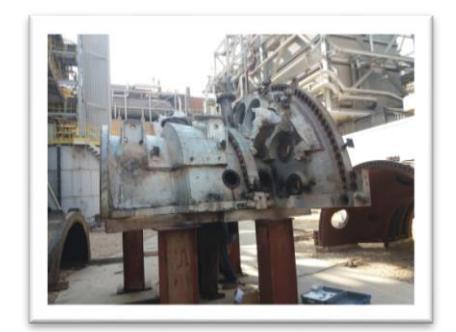
Lifted casings of the turbine, compressor and exhaust then dismantled the acceleration mechanism.

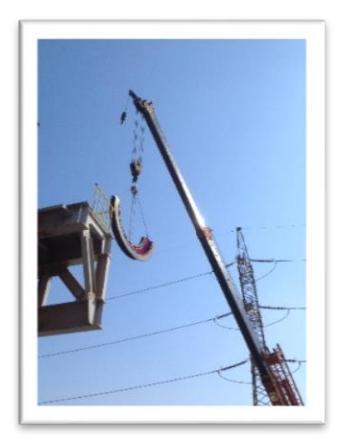
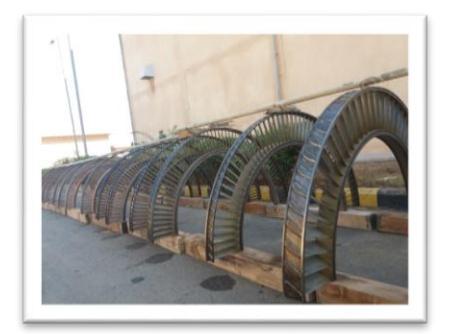
Cleared the way for removal of all stages then disassembled the upper stationary blades starting with the first stage of the turbine till the fourth, and 19 stages of the compressor.

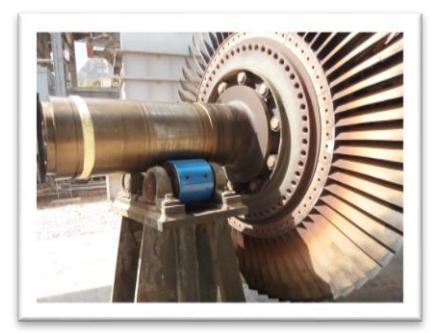
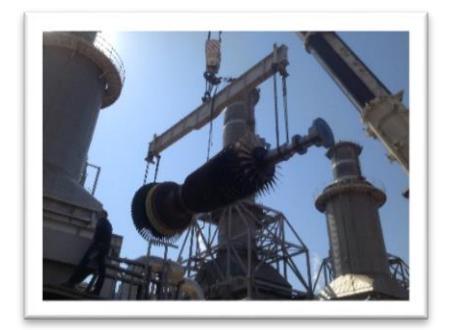
Removed the torque tube cover and air ducts inside the combustion chamber, then lifted the turbine axis from its bed and placed it on the fixed base.

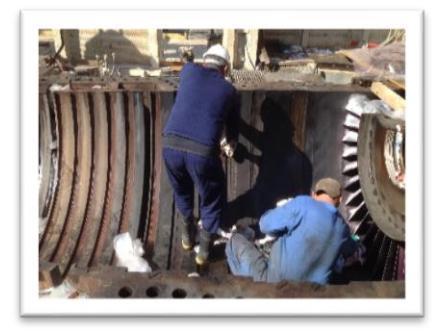
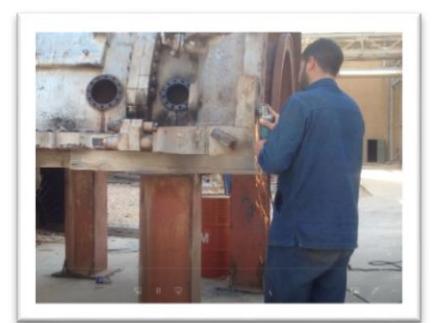
After GT4 was dismantled, the rotor, blades and all peripherals were carefully cleaned and soldered in preparation for the maintenance process.

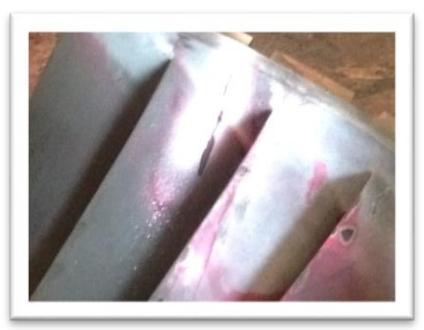
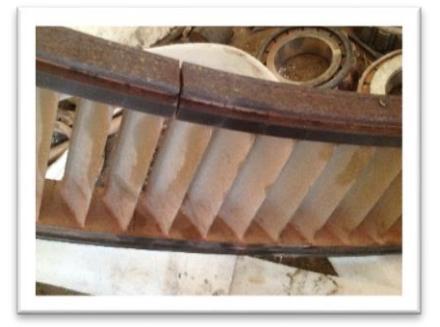
A full inspection of all the dismantled parts took place. The types of tests implemented on the stationary blades and rotating blades were non-invasive and included paint tests (PT) and ultrasonic tests (UT). The inspection and tests conducted revealed some cracks, defects and decomposition of blades and other parts.

Parts that were diagnosed as being damaged beyond repair were replaced with new parts provided by UNDP. Most of the damaged parts that were replaced had undergone 80,000 hours of operation which exceeded the manufacturer recommendation by 5000 hours. The major parts donated by UNDP used in the rehabilitation were the following:

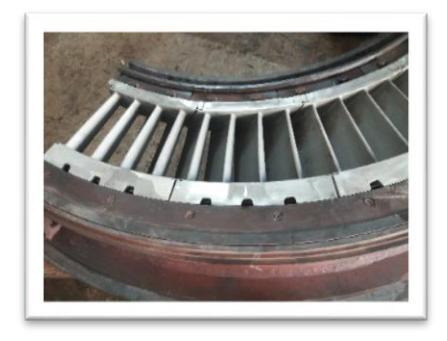
• Stationary blades for stage 3 of the turbine

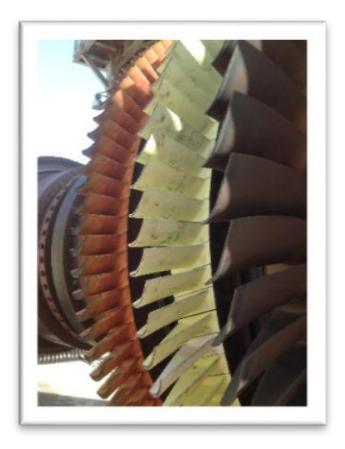
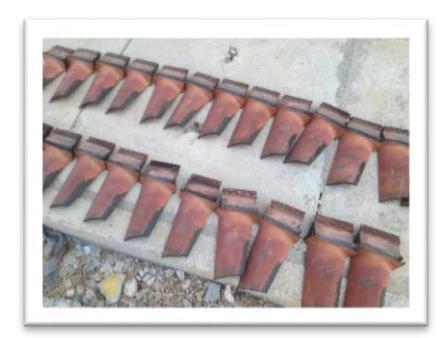
• Rotating blades for stage 2 of the turbine axis rotor

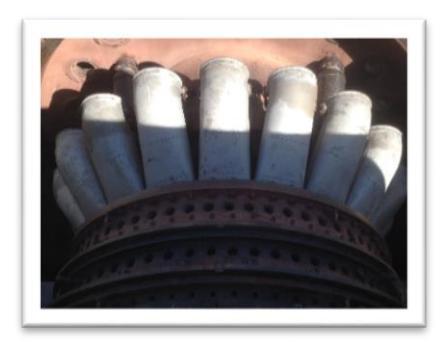
Hot gas paths

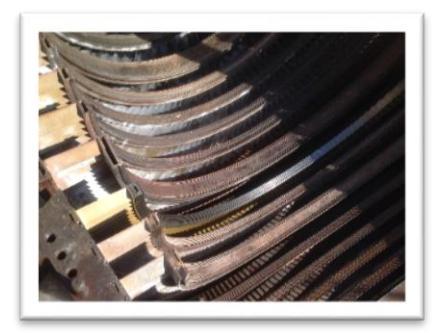
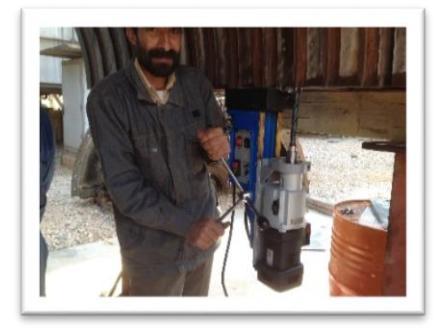
• Stationary blades for stage 12 of the compressor

The new stationary blades for stage 12 of the compressor are a different design from the old one, and not a perfect fit. So the manufacturer proposed a modification on the upper casing of the compressor to accommodate the new blades. A special tool, the compressor diaphragm drill, was donated by UNDP to rectify this discrepancy so the new blades could be installed.

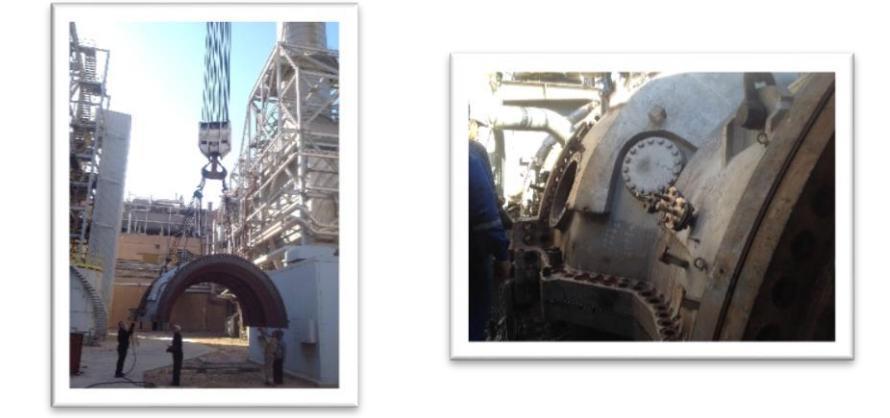
Stationary stages, the rotor, beds, acceleration mechanism, rotor casing, exhaust casing, compressor cover, hot gas paths, combustion chambers, locks, flame detectors, lighters, air and oil pipes, air ducts, man holes, and turbine ceiling and insulation.
